**ETS 300 347-1**  
pr A1

**This draft amendment A1, if approved, will modify  
the European Telecommunication Standard ETS 300 347-1 (1994)**

**Signalling Protocols and Switching (SPS);  
V interfaces at the digital Local Exchange (LE);  
V5.2 interface for support of Access Network (AN);  
Part 1: V5.2 interface specification**

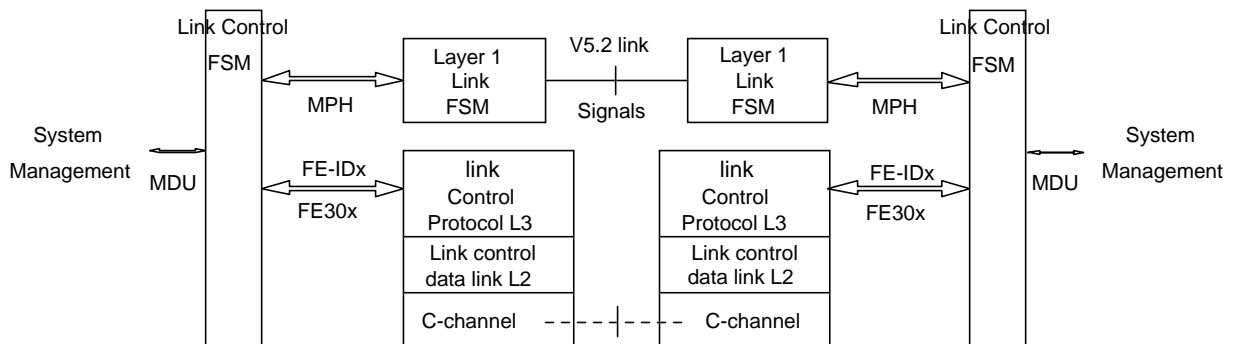
**Page 46, figure 11**

Add the formerly "invisible" text to figure 11:

**Figure 11: Link control functional model**

- Clause 16, figure 11: The invisible text is reconstituted from an earlier version.
- Subclause 16.2.4.5: A note is added about the sending of a notification to system management.

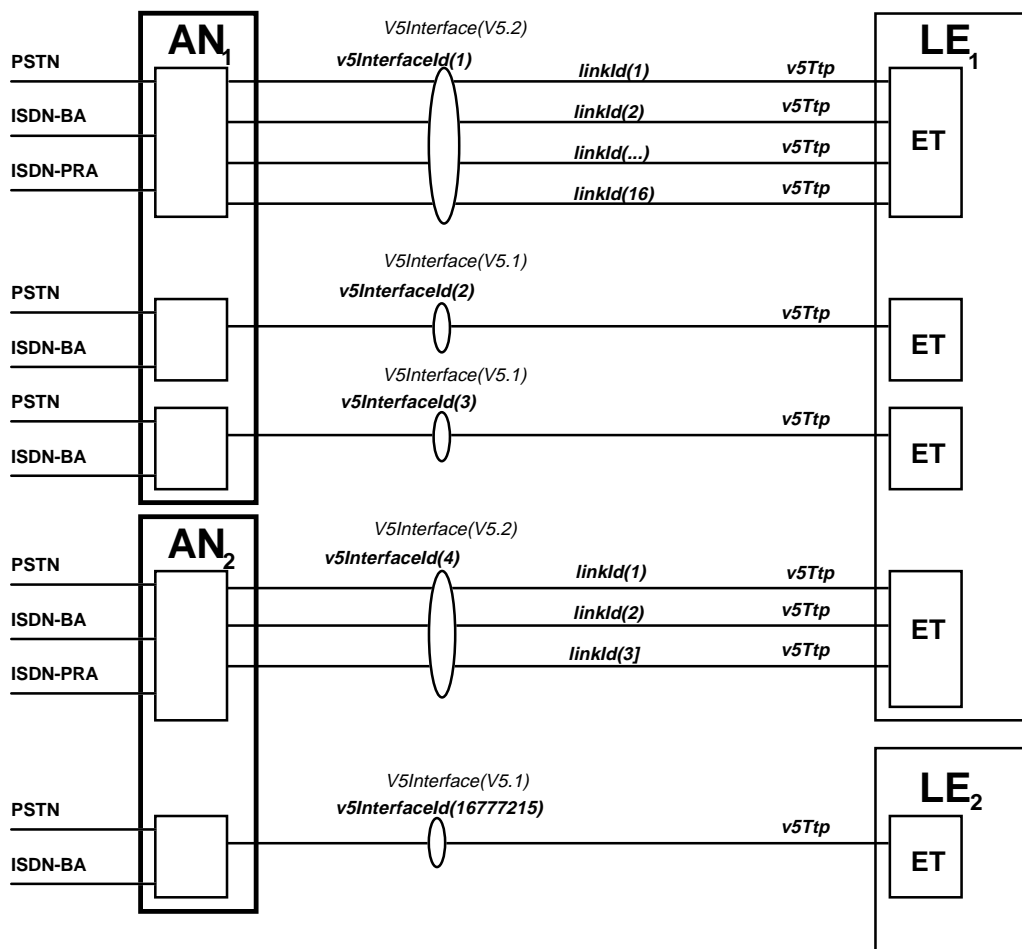
Figure F.1: A possible AN/LE configuration using the V5 standard

Figure F.1 shows one case with two LEs and two ANs connected to each other via five V5 interfaces with the following given v5InterfaceID values: 1, 2, 3, 4, up to  $2^{24}-1$ , 16777215). LE<sub>1</sub> is connected to AN<sub>1</sub> and AN<sub>2</sub> using V5 interfaces of type both V5.1 and V5.2 to the same AN. Both LE<sub>1</sub> and LE<sub>2</sub> are connected to AN<sub>2</sub> using separate V5 interfaces of different types.

For V5.1 the interface ID is unique for everything related to this particular interface. The same is true for V5.2 with the difference that the linkID differs for each of the 2 048 kbit/s links.

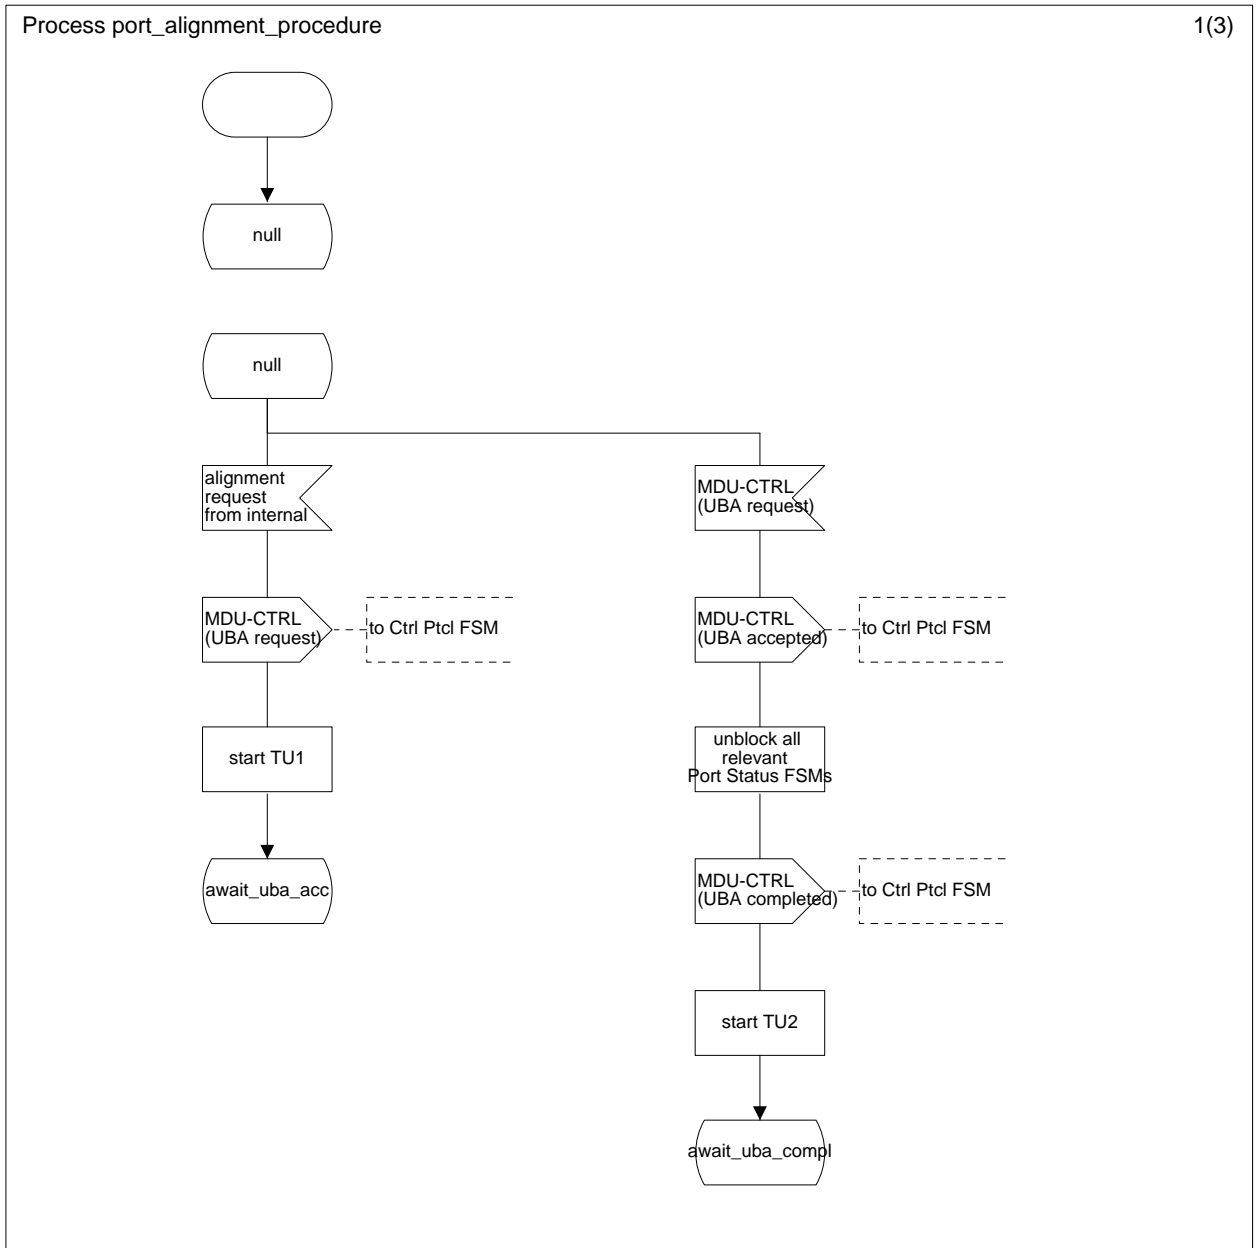
**Figure L.23a.1: Accelerated port alignment procedures AN-side (sheet 1 of 3)**

**L.1.8.7 Accelerated port alignment procedure**

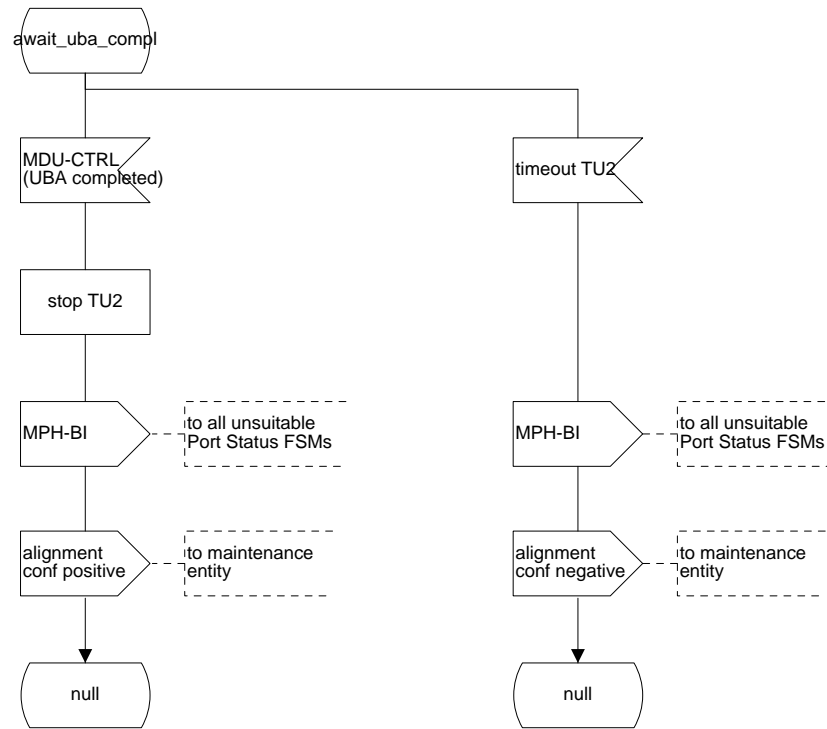
Figure L.23a.3: Accelerated port alignment procedures AN-side (sheet 3 of 3)

Process port\_alignment\_procedure
